INFRASTRUCTURE VICTORIA

PORTS PLANNING ADVICE ENGINEERING SERVICES

DREDGING & RECLAMATION

Report No.: BA1701

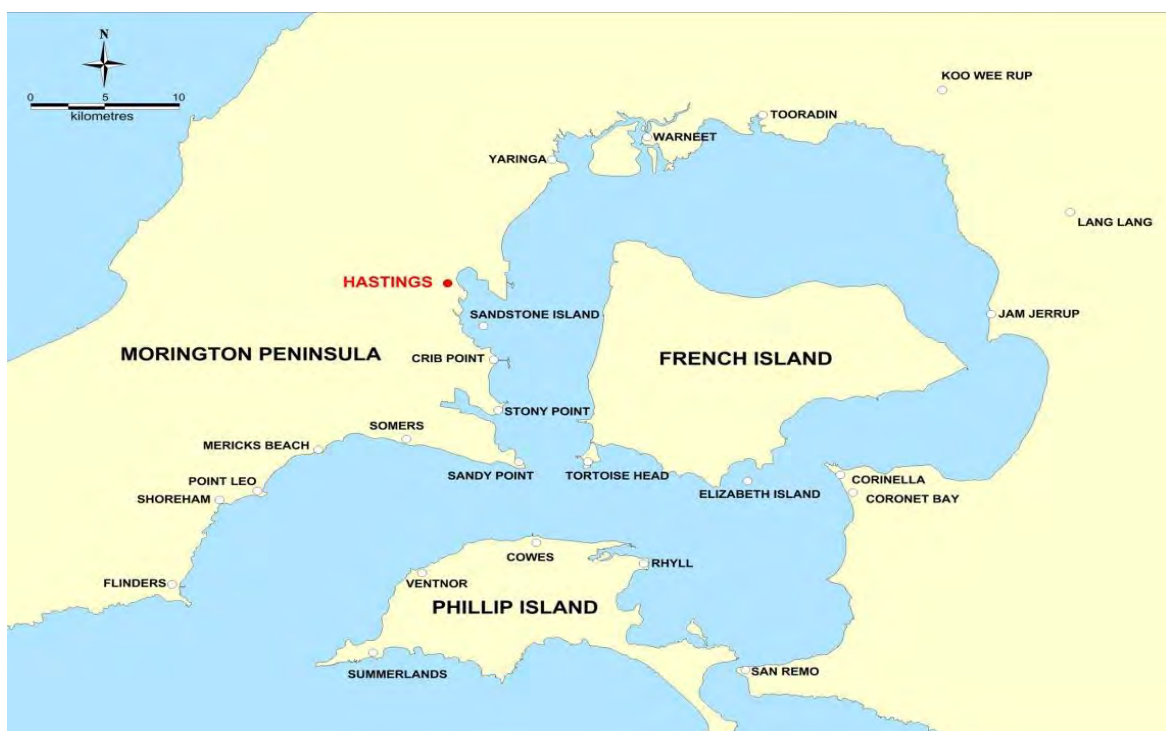
Figure 1 Proposed Hastings Port Location

It was planned that the Hastings port be located near Hastings in Western Port, immediately north of the existing OneSteel port facility in Western Port, thereby taking some advantage of the existing shipping channel.

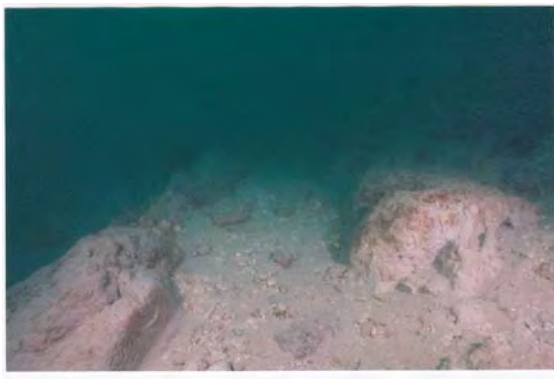
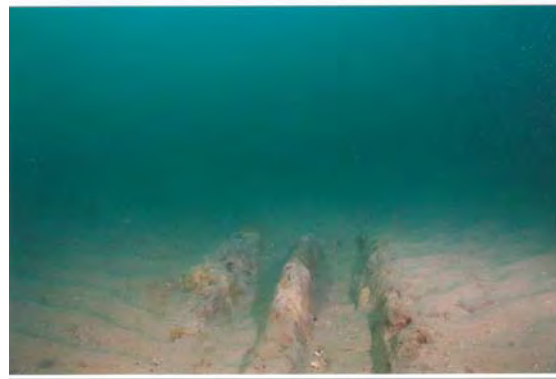
Figure 13 Rock in the South Channel

A sandstone layer of limited strength is present just below the present depth level over most of the South Channel.

To date this rock has been able to be dredged by a jumbo trailer dredger, but only where patches have occurred above design depth at that time. Should further deepening of the South Channel be planned a cautionary approach should be taken as a cutter dredger may have to be deployed to crush this rock prior to removal by a TSHD. A cutter dredger operating in the South Channel will incur very significant lost time due to shipping movements, thereby potentially making any deepening very expensive.

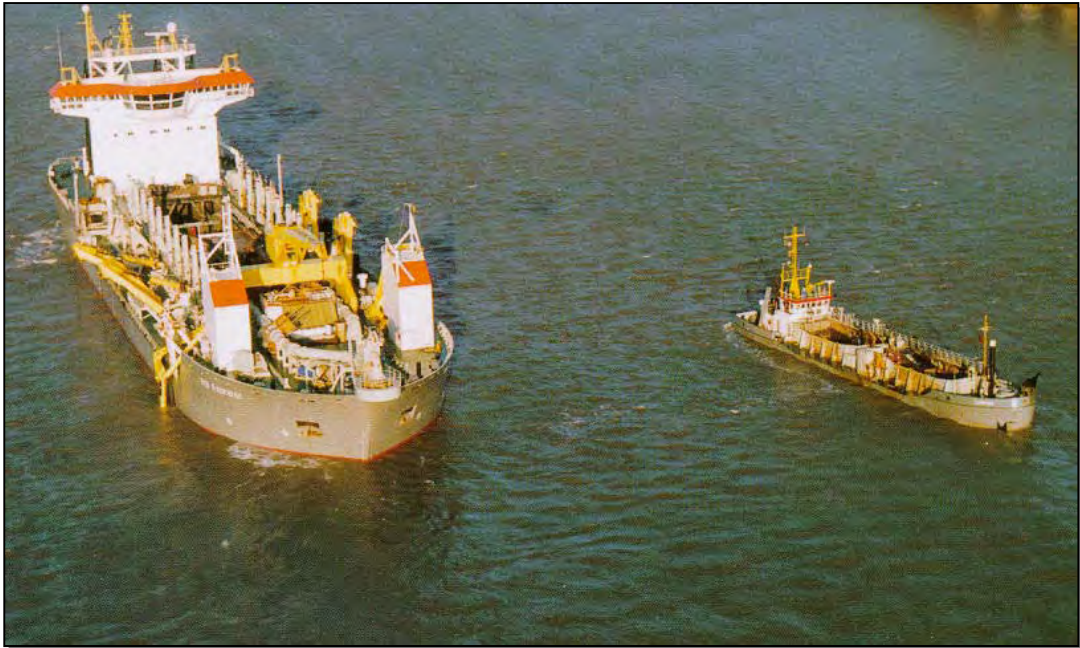
Figure 14 Trailer Dredger Size Comparison

Photograph 2 shows a small trailer dredger of approximately 1,000 cubic metres hopper capacity compared to a trailer dredger with a hopper capacity of approximately 24,000 cubic metres.

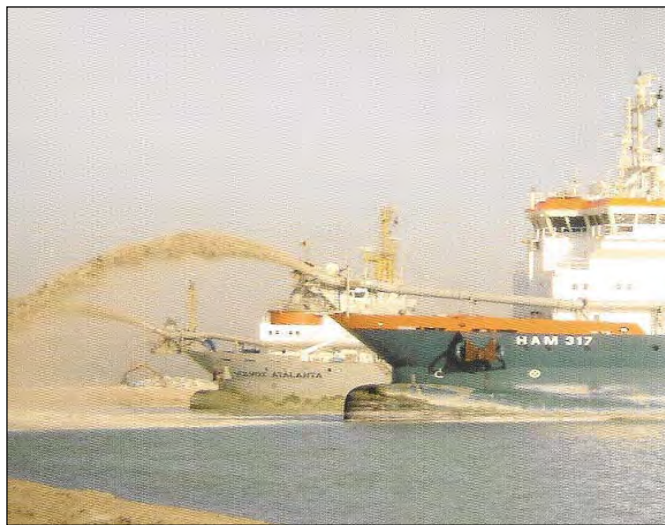
Figure 17 Trailer Dredgers Rainbowing

This method of discharge allows material to be jetted over the bow of the dredger through a nozzle, and is used where the reclamation areas are close to the discharge site. Typically, a large trailer dredger can discharge over a distance of 50 to 80 metres, depending upon the power available on the dredge pumps and the median grain size of the material being dredged.

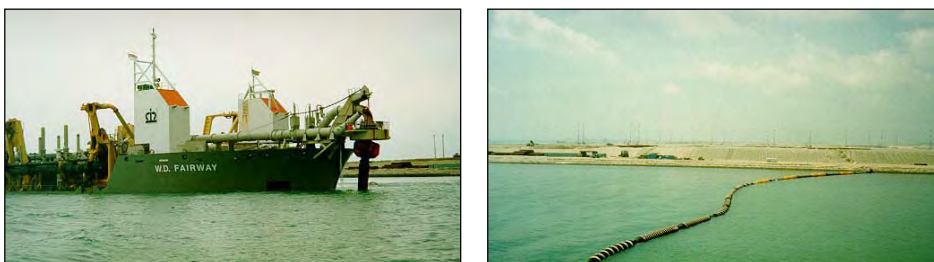
Figure 18 Trailer Dredger Pumping Ashore

Typically, most trailer dredgers are also capable of discharging material from their hopper into a floating pipeline via a bow connection and then into shore pipeline for discharge into a reclamation area.

This work method may be limited by the pumping distance required due to the design of and power available on the dredge pump(s). However, this can be supplemented with the use of booster pumps.
