Port of Hastings Development Project

Dredging History in Western Port

Port of Hastings Development Authority

Final Working Draft (Revision 0)

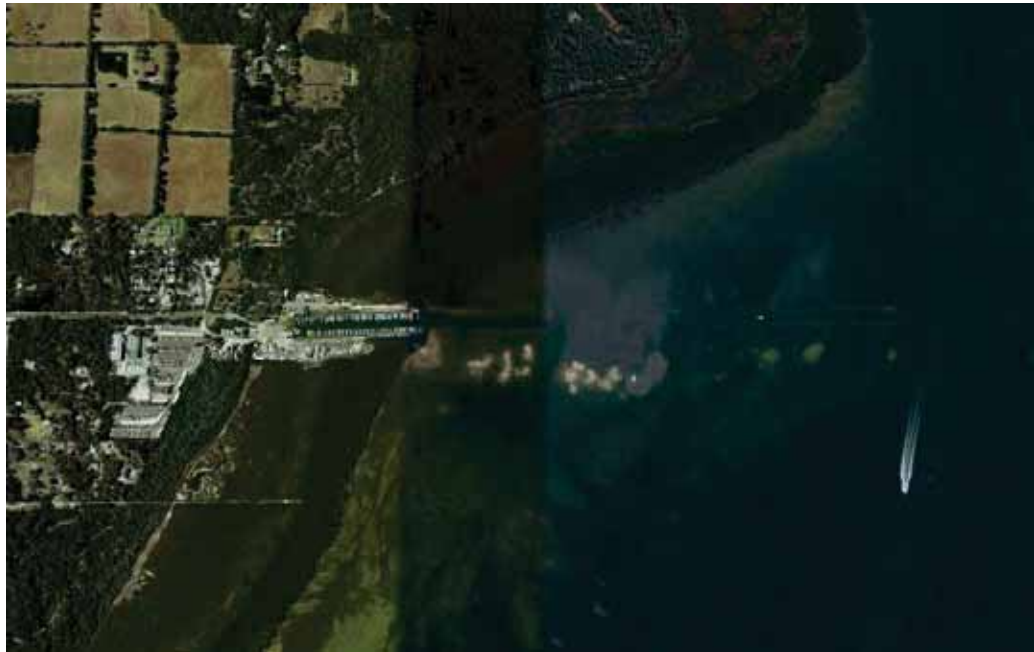
Figure 1: View of shallow areas of dredged material placement that provide bird roosting sites to the south of the Yaringa access channel (Google Earth Pro, 2014)

The access channel into Yaringa Boat Harbour is dredged periodically to maintain access for deep-drafted yachts. The channel is subject to siltation and this material is typically removed with a small CSD and pumped to an approved disposal site within the waterway around 50m south of the channel alignment. The 2004 EPBC Act Referral for maintenance dredging of the channel reports that 20 years of routine maintenance dredging has enhanced the ecological value of the region by providing a bird roosting area at the disposal site (refer **Figure 1**).

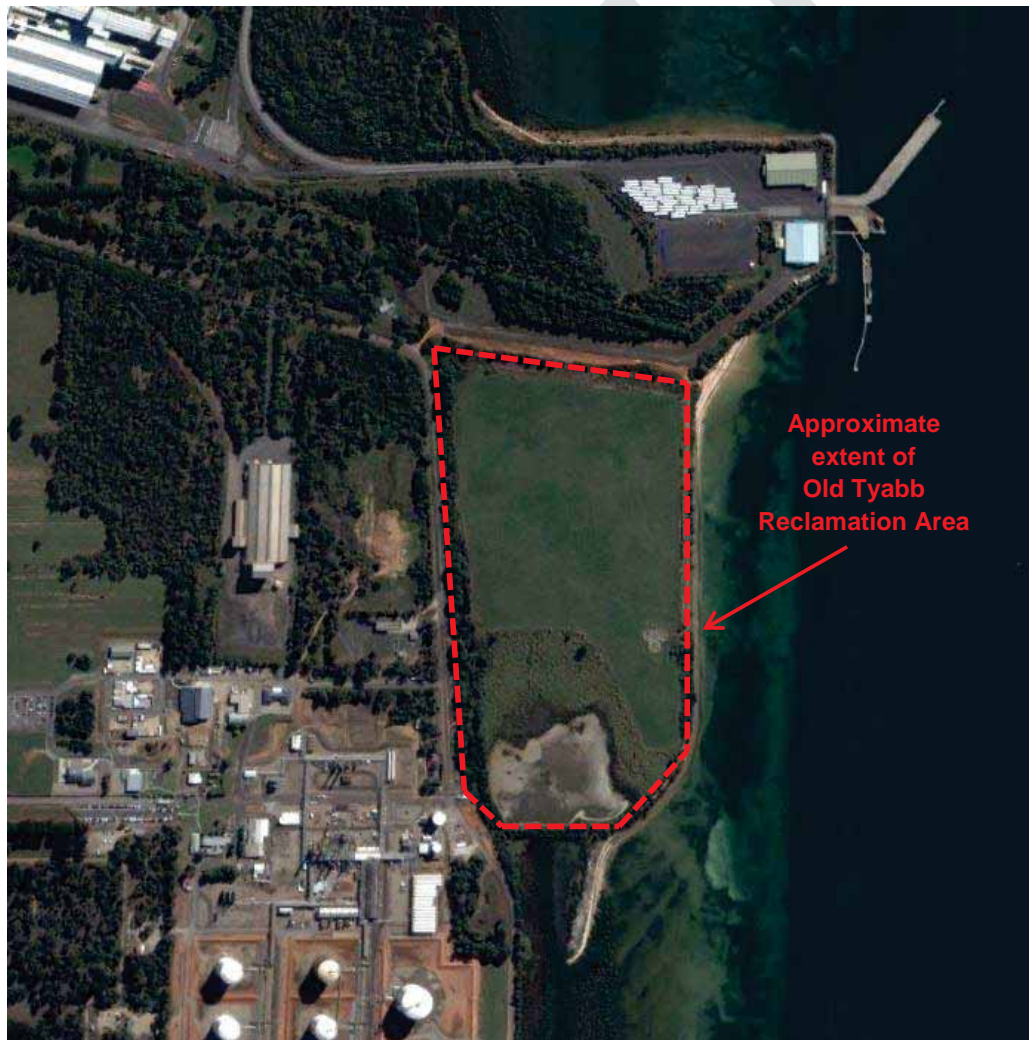
Figure 2: Aerial view of BlueScope Wharf facility and Old Tyabb Reclamation Area to the south (Google Earth Pro, 2014)

The Old Tyabb Reclamation Area is located to the immediate south of the BlueScope Steel Wharf as shown on **Figure 2**. It is currently predominantly covered with lucerne (see **Figure 4**), with the exception of the access road around its northern and eastern perimeter and a low-lying salt marsh area (see **Figure 5** and **Figure 6**) at the southern end. The area covered with lucerne is used as a paddock for cattle grazing. The salt marsh area is believed to be the result of the former use of this area as a drainage basin during the original reclamation of the site (AECOM GHD, 2013).

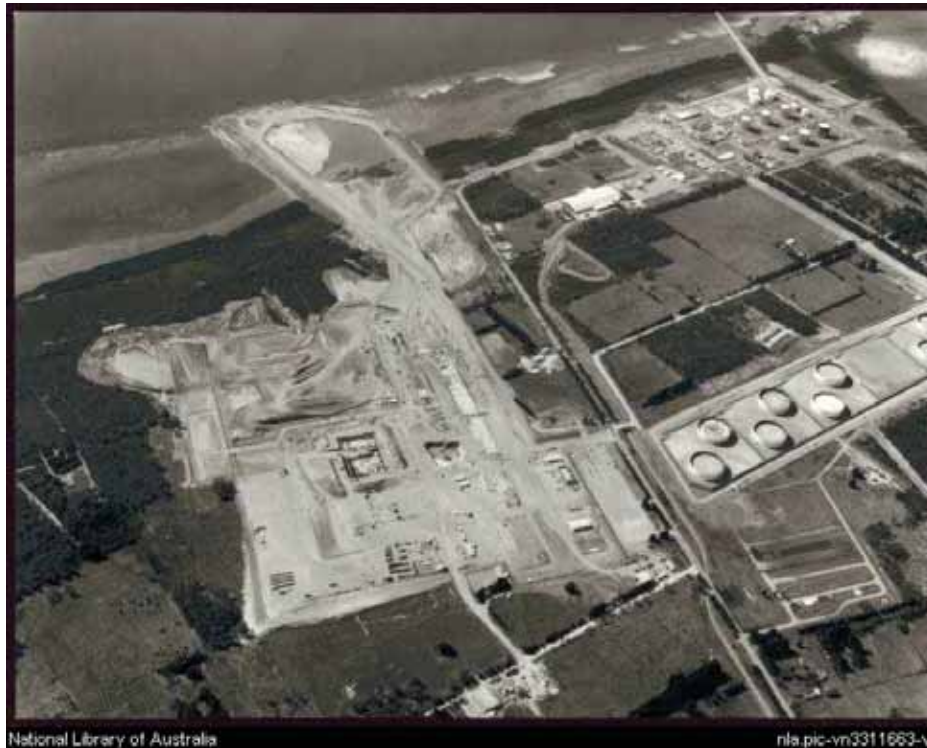
Figure 3: Oblique aerial photograph taken in 1971 showing land based reclamation of the BlueScope site (AECOM GHD, 2014)

The land behind the BlueScope Steel Wharf, to the north of the Old Tyabb Reclamation Area, is understood to have been formed by land-based reclamation during development of the site in 1971 (refer **Figure 3**).

During Phase 1 of the dredging works associated with the Long Island Point development in 1968-1969, 153,000m³ of material was pumped into two separate mounds located WSW of the Long Island Point jetty (refer **Figure 9**). The placement of dredged material was “among the mangroves” (Watson, 1974) that existed around Long Island Point and adjacent to the extensive tidal flats within Hastings Bight. A photo of the two mounds of dredged material was taken several years after the completion of the Long Island Point dredging campaign (refer **Figure 10**) as part of investigations undertaken by Watson (1974). Watson (1974) states that “the tailing heaps have now eroded down to two low mounds visible among the mangroves”. The island formed by the placement of dredged material within Hastings Bight is also shown in the top right hand corner of **Figure 3**.

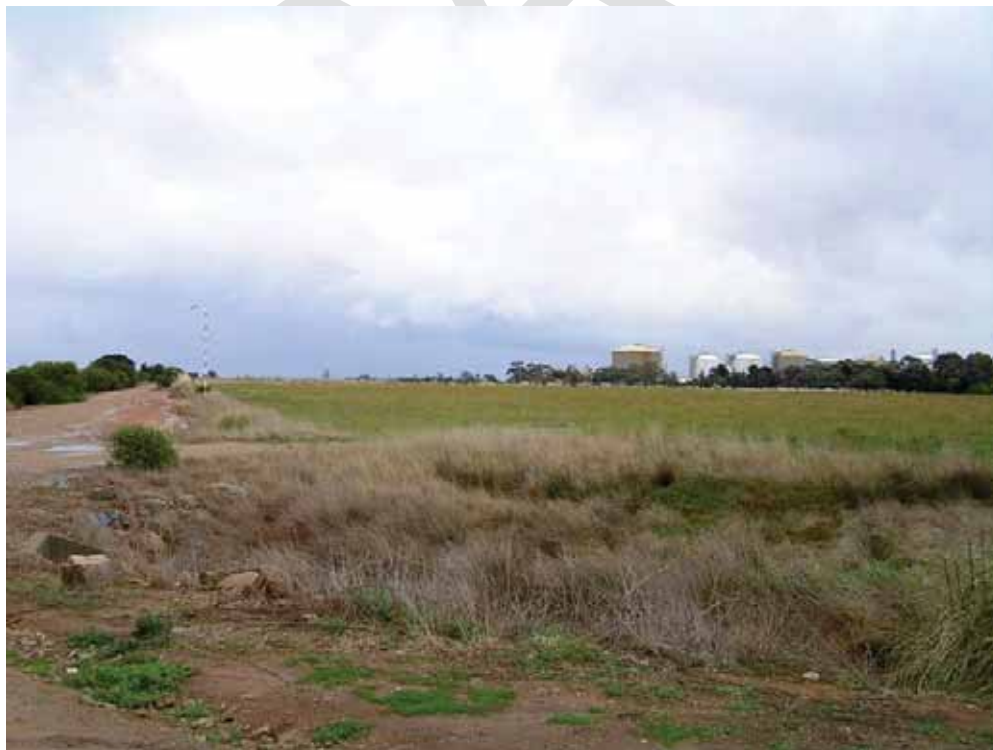
Figure 4: Looking south across the Old Tyabb Reclamation Area from northern boundary (AECOM, 2009b)

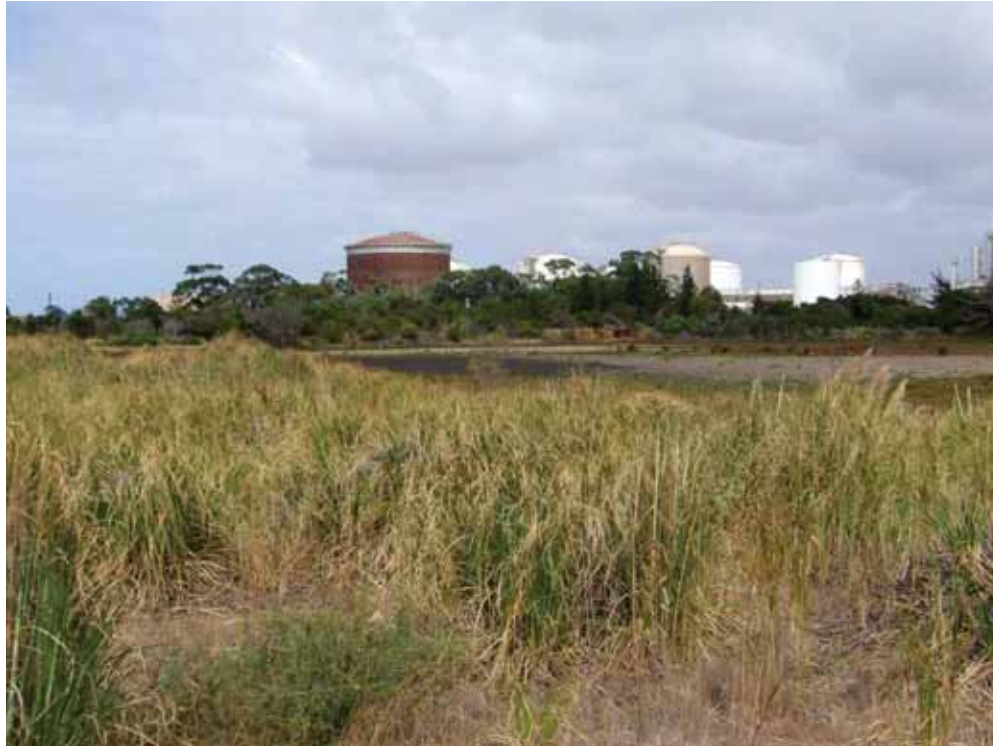
Figure 5: Looking south across the salt marsh area at the southern end of the Old Tyabb Reclamation Area (AECOM, 2009b)

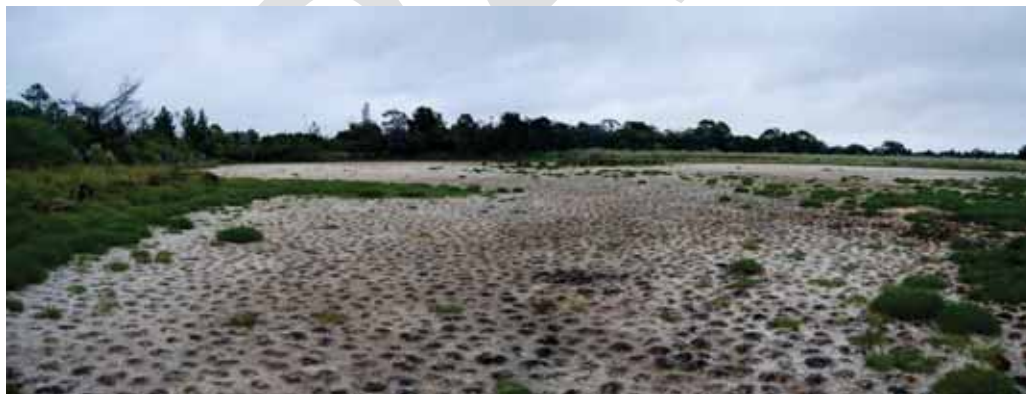
Figure 6: Looking west across the salt marsh area at the southern end of the Old Tyabb Reclamation Area (AECOM, 2009b)

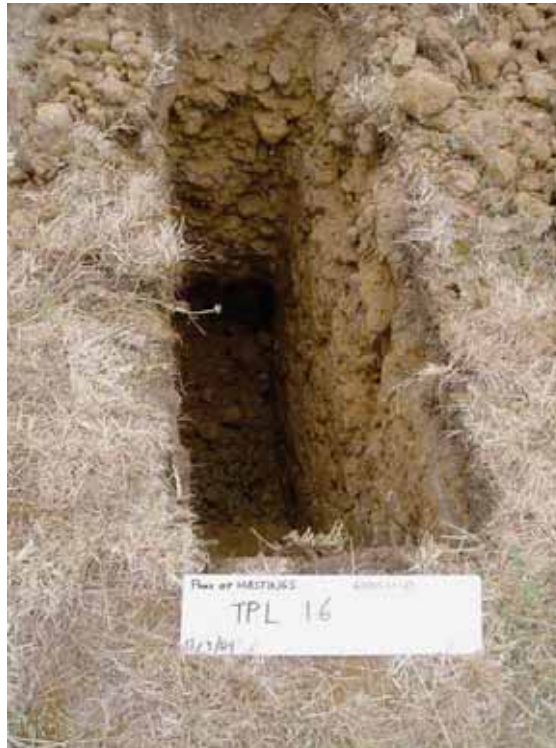
Figure 7: View into Test Pit TPL16 within the Old Tyabb Reclamation Area showing clay balls within soil profile (AECOM, 2009b)

Geotechnical investigations have been undertaken by AECOM (2009b) to characterise the subsurface conditions across the Old Tyabb Reclamation Area. This determined that the fill thickness (i.e. reclamation material) overlying the natural soils beneath the reclamation was variable and ranged from a maximum thickness of 4m to a minimum thickness of 1.3m within the salt marsh area to the south (i.e. the fill thickness reduced from north to south). The reclamation material generally comprised a mixture of sand and clay, with the clay in some areas presenting as cobble sized lumps within a sand/sandy clay matrix (see **Figure 7** and **Figure 8**). This was thought to be the result of the remnant “balling” of clay materials from

CSD operations (AECOM, 2009c). The reclamation material was generally dry and desiccated in places near the surface and the soil strength inferred from DCP testing generally indicated decreasing strength with depth. The material within the lower portion of the reclamation profile typically comprised very loose to medium dense sand and soft to firm sandy silt/clay.

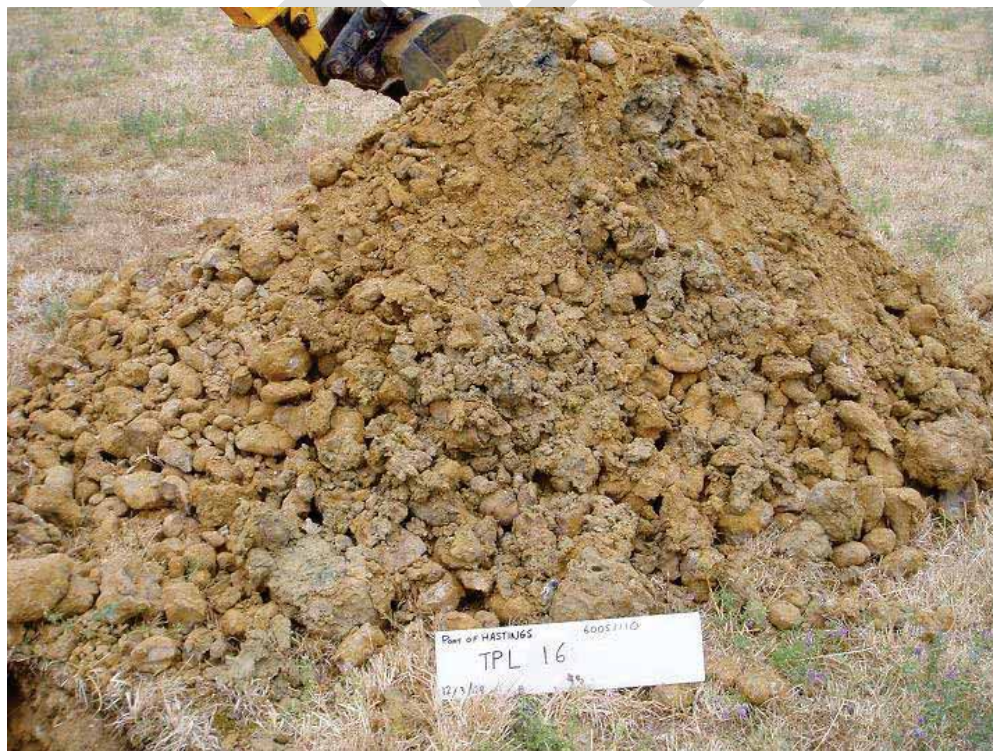
Figure 8: Material excavated from Test Pit TPL16 showing clay balls (AECOM, 2009b)

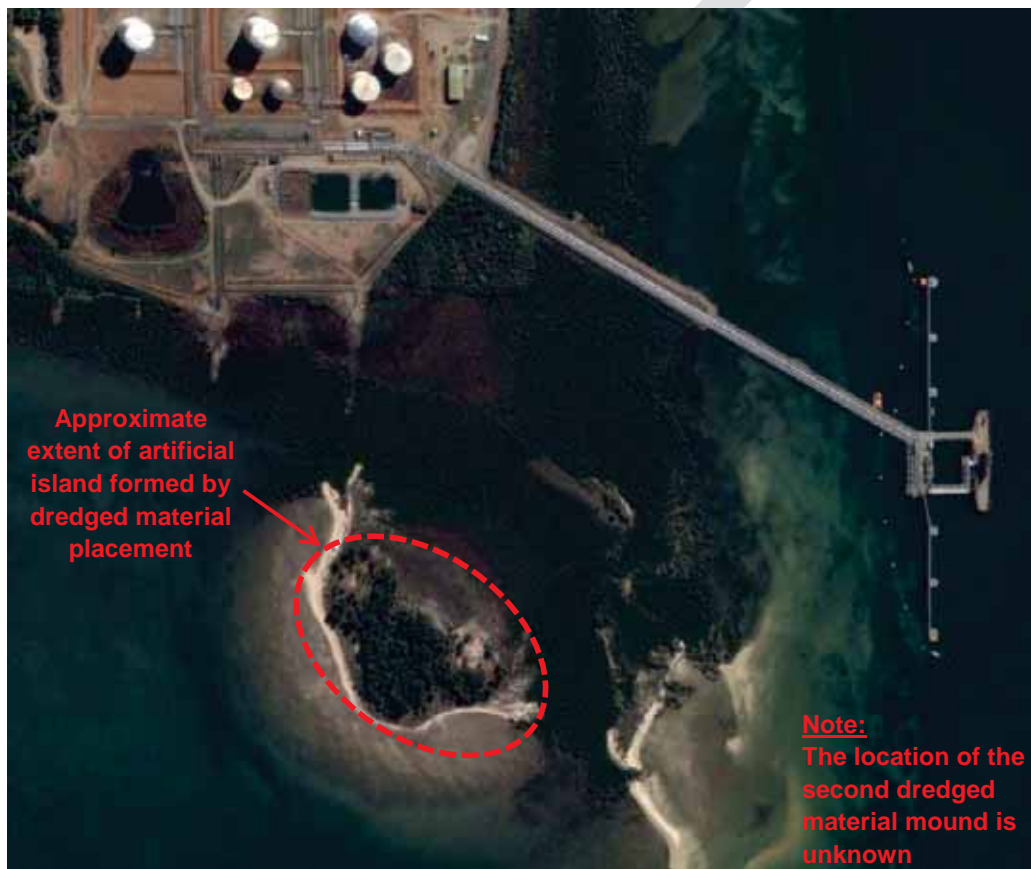
Figure 9: Aerial view of Long Island Point Jetty and artificial island formed by placement of dredged material to the south (Google Earth Pro, 2014)

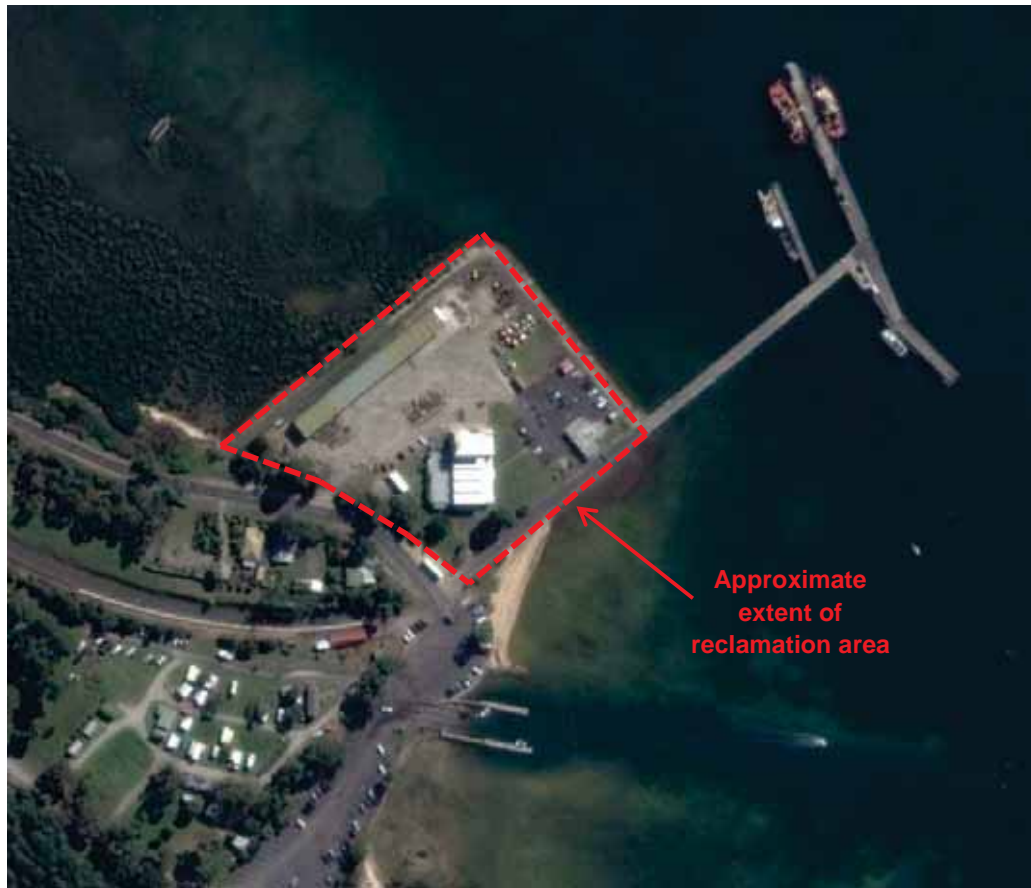
Figure 12: Aerial view of Stony Point Jetty and reclamation area (Google Earth Pro, 2014)

The reclamation area behind Stony Point Jetty was created in 1965 from 142,000m³ of material dredged in the vicinity of the jetty by a CSD and pumped behind the jetty to provide a land area for public carparking and port authority workshop and office areas (see **Figure 12**). The reclamation area is currently used as the Patrick Ports Hastings depot, which comprises an administration building and several sheds and workshops, including a machinery shed, buoy workshop, dangerous goods store, tug office and amenities (see **Figure 13**). Road access to the depot and carparking area is provided along the southern perimeter of the reclamation area, which is protected by a sloped masonry seawall structure (see **Figure 14**). The eastern and northern perimeter of the reclamation area is protected by a rock revetment (refer **Figure 15**). The nearshore area in the vicinity of the reclamation comprises intertidal mudflats that support a stand of mangroves to the immediate north (see **Figure 16**).

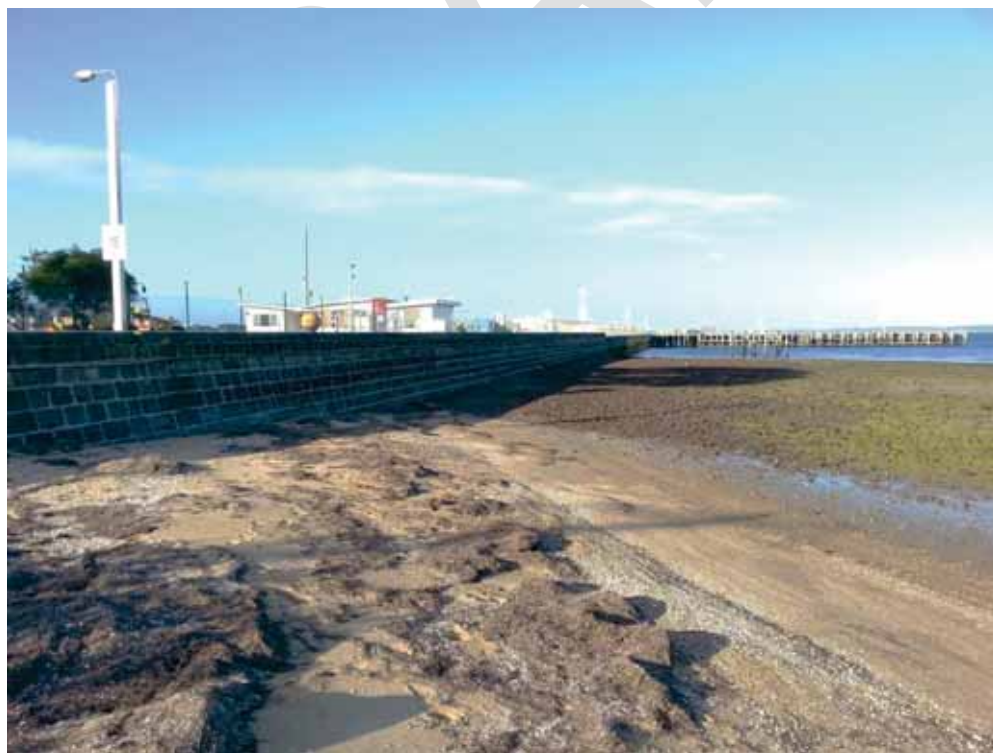
Figure 14: View of the southern side of the reclamation area

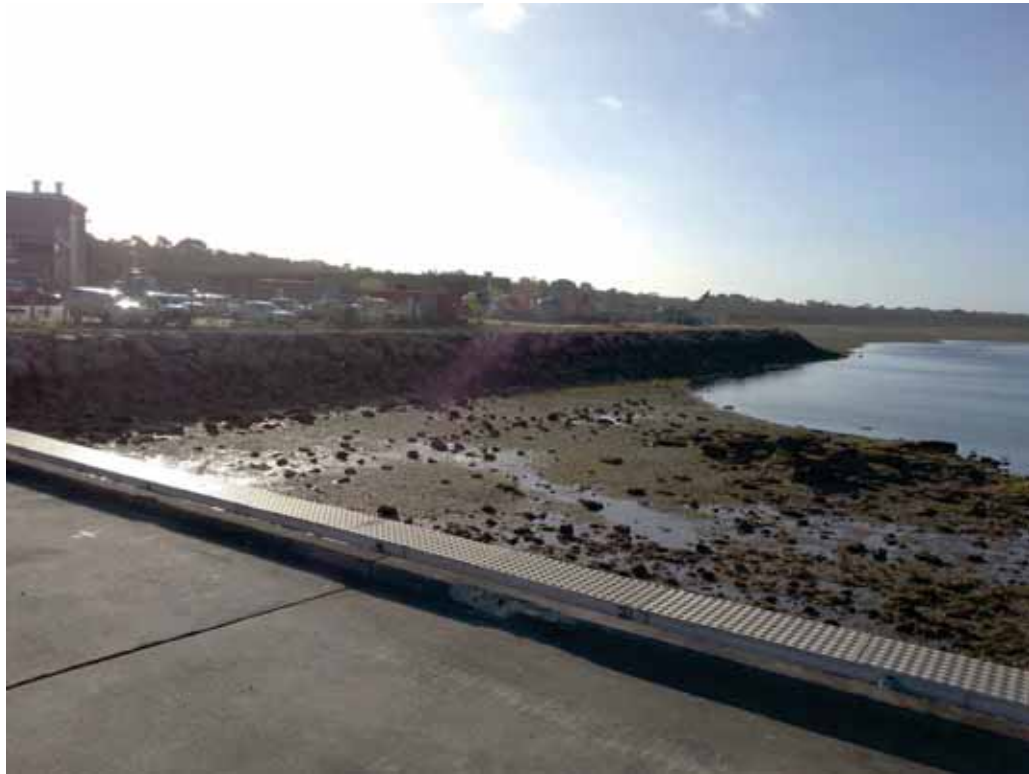
Figure 15: View of the rock revetment along the northern perimeter of the reclamation area

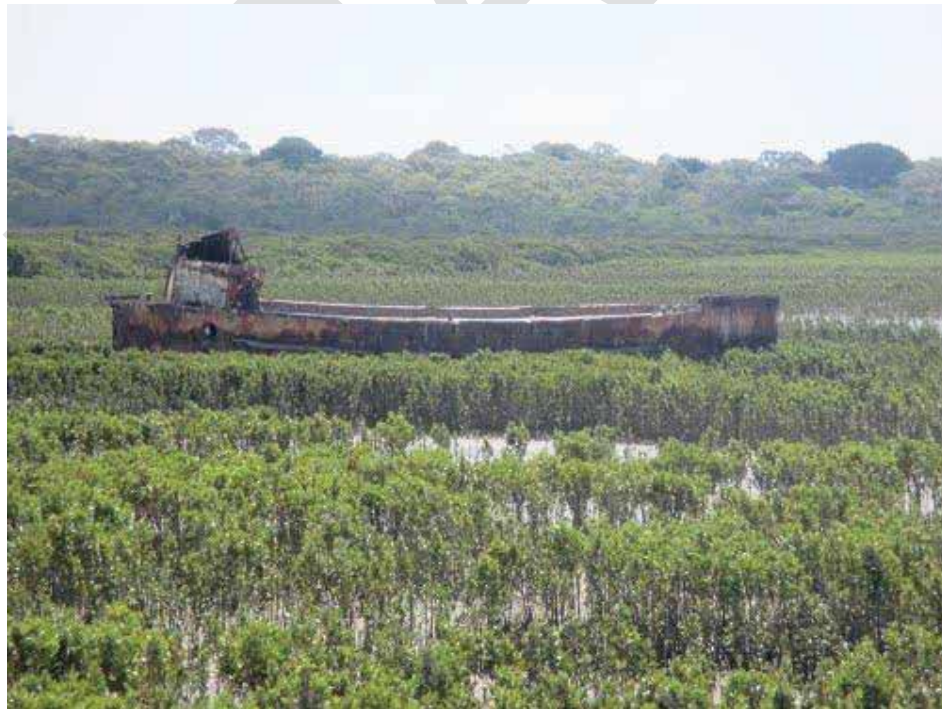
Figure 16: View of mangroves to the north of Stony Point reclamation area (Google Earth Pro, 2014)

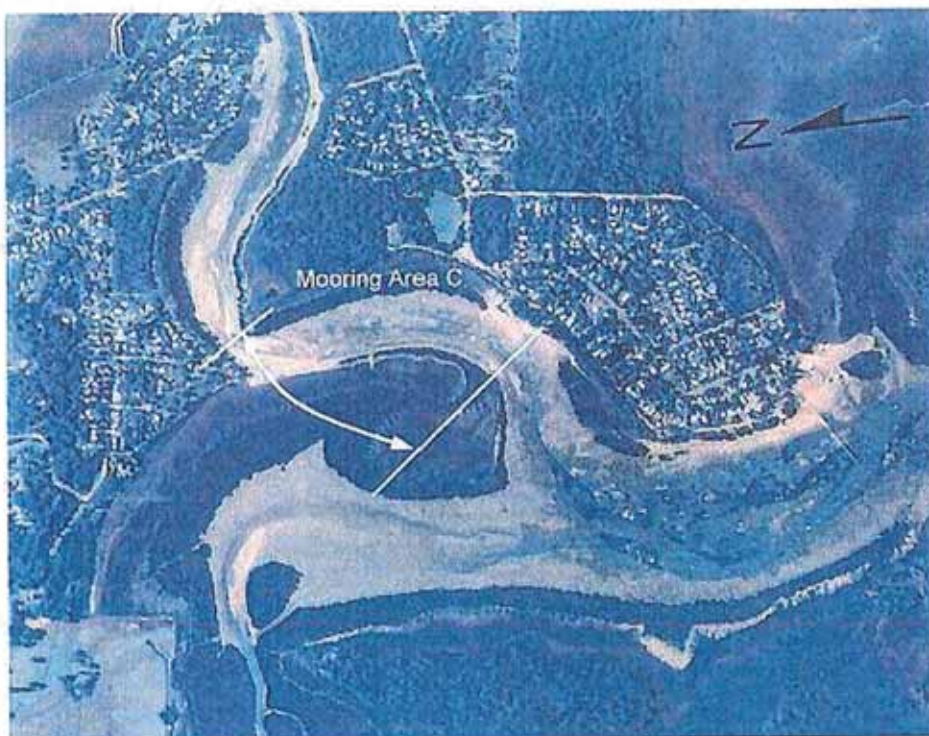
Most mooring areas at Warneet are, and always have been shallow and inaccessible at low water. The area varies in depth with distance from the channel, but is satisfactory for existing vessels and depths are stable.

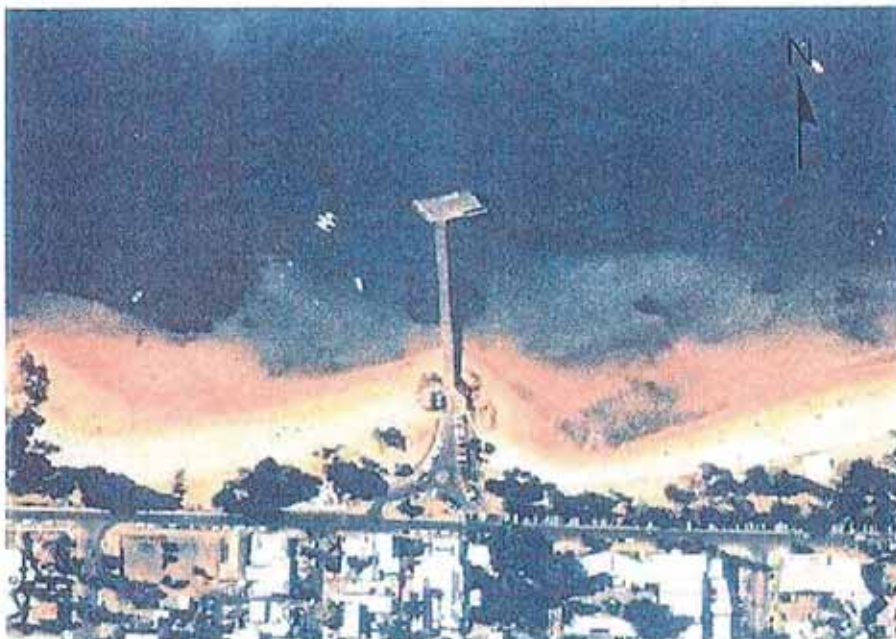
The jetty provides adequate water for the ferries and recreational vessels using the pier and there is no evidence of siltation. The strong tidal currents, local wind waves and swell tend to cause minor shoreline variations, but overall the pier depths are more than adequate.

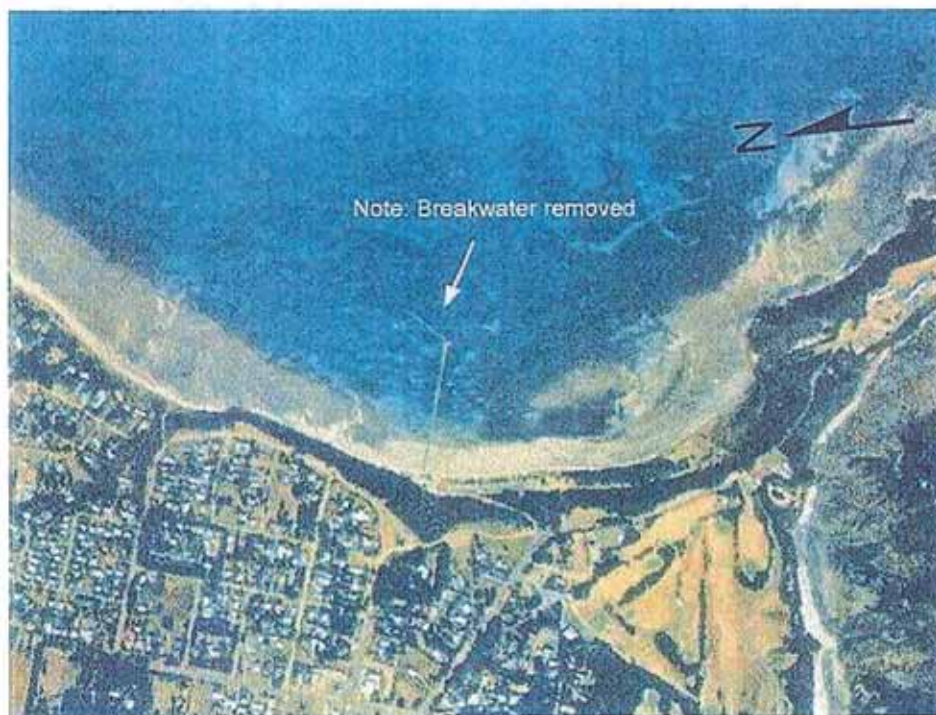
Flinders Pier is partially in the lee of West Head. The pier provides adequate but shallow water depths at the lower landings for a range of recreational and commercial activities. The seabed level is stable and unchanged over time.

The breakwater shown in the photograph has been demolished at the time of writing.

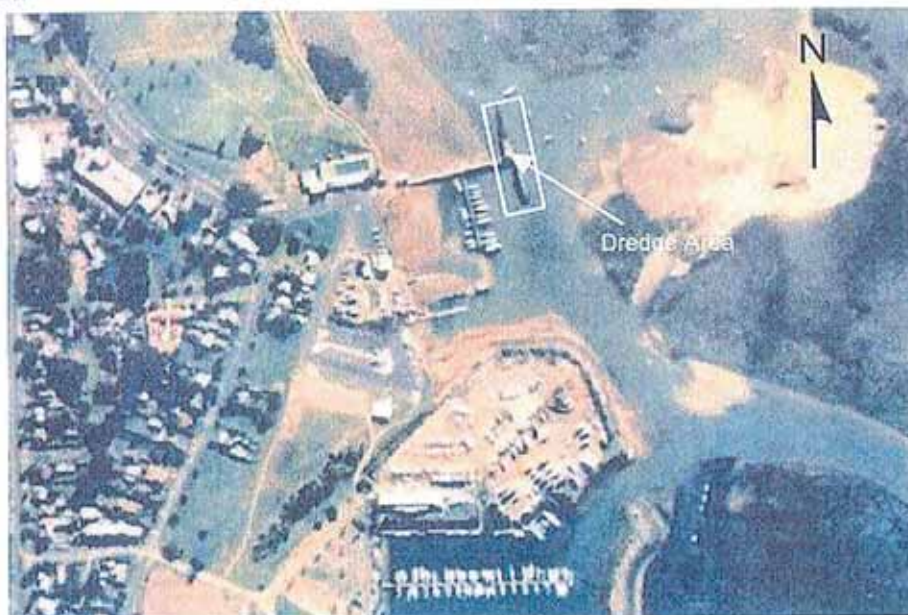
Hastings pier is subject to the general slow siltation within Hastings Bight. Generally though, depths are adequate and any seabed changes are slow and incremental. Parks Victoria were not able to provide information regarding the dredging history of the site but, based on staff experience, we intuitively believe that the area has been exposed to some minor dredging work.

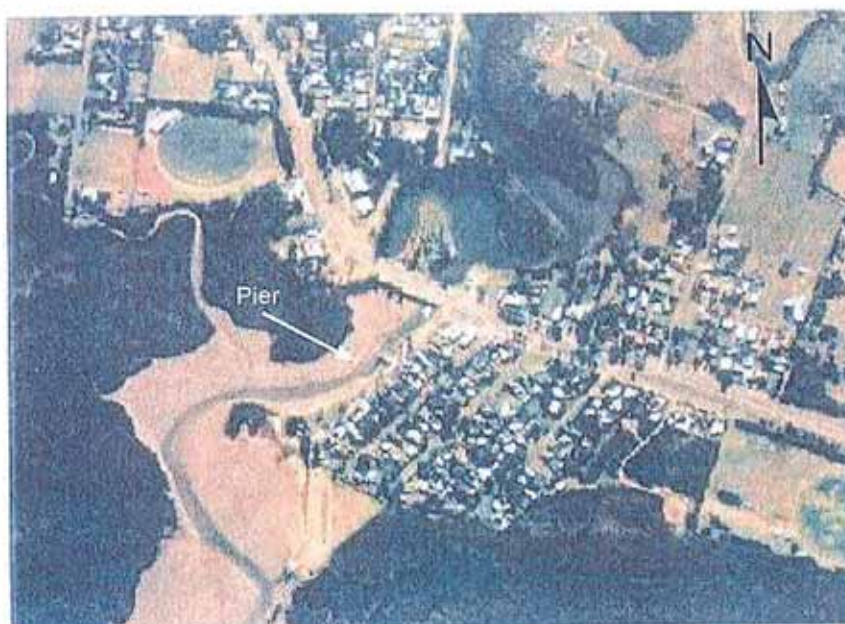
The Tooradin pier caters for a range of small vessels and provides adequate water for most existing needs. Conditions are quiet at the pier and sedimentation is slow and incremental. Based on anecdotal information, the area is said to have shoaled since the jetty was rebuilt in the early 1980's.

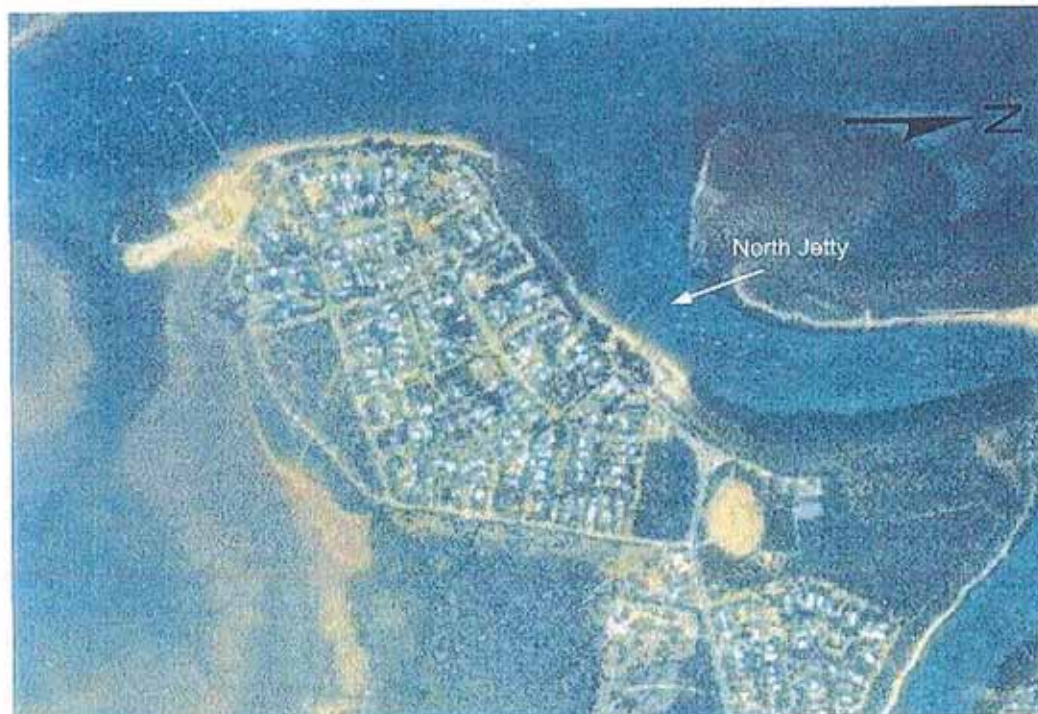
The small timber jetty caters for small craft and provides adequate water depths. Based on anecdotal information the area is presumed to have stable depths.

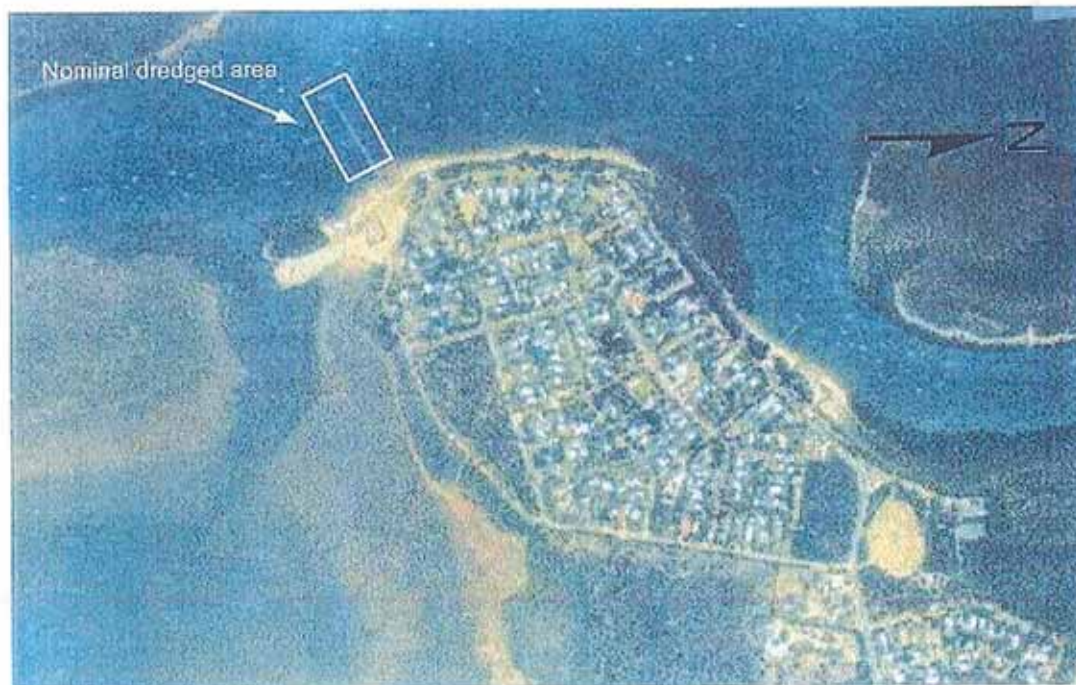
The reinforced concrete jetty caters for a range of craft and provides adequate water depths. Based on anecdotal information the area is presumed to have stable depths. The nominal dredged areas shown are based on anecdotal information. Spoil area(s) will be subject to contaminant testing and EPA review.

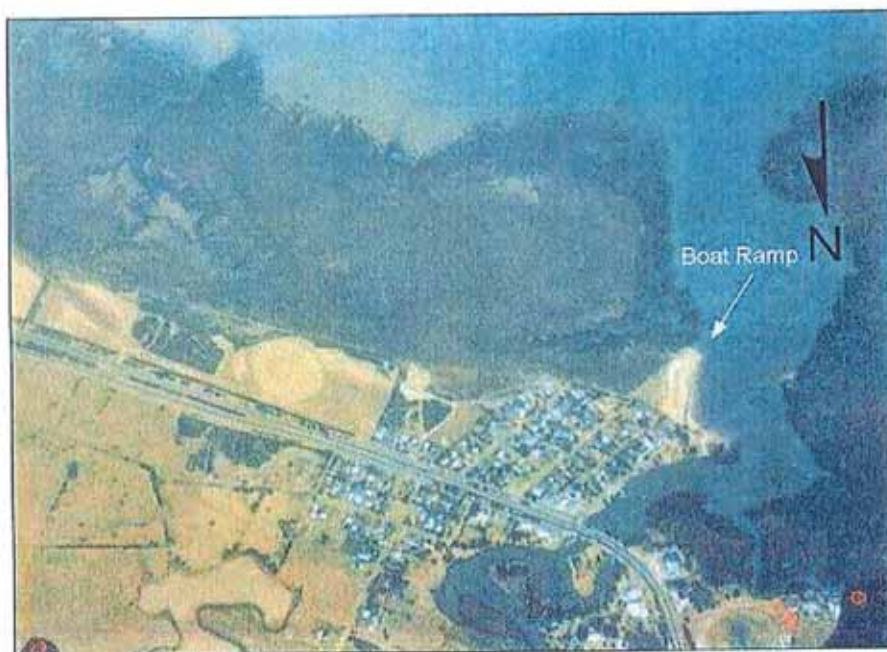
The ramp and approach channel to the main channel was dredged in the early 1990's and material pumped ashore. Since then we understand that annual clearing with a long reach back hoe is required for the vicinity of the ramp, but this quickly silts again within 6 months. The information was gained anecdotally and there are no records of dredge sites and disposal areas.
